ASBESTOS-CONTAINING MATERIALS SURVEY REPORT

**Groundwood Building Complex
Former Newstech NY, Inc. Paper Mill
Deferiet, New York 13628**

CONDUCTED: January 2008

SUBMITTED: February 13, 2008

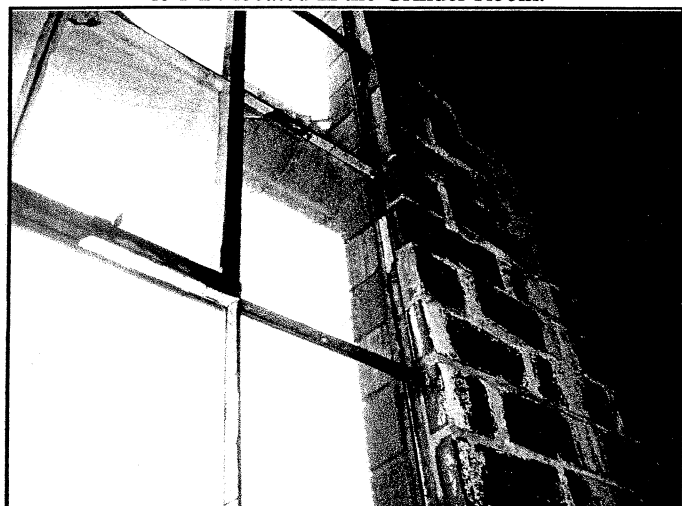
Approximately two-thousand six-hundred forty five linear feet (2,645 lf) of asbestos-containing white/gray interior window glazing compound was identified on windows located in Areas 1-38, 1-28 and 1-30. The glazing compound is located along the interior of the glass panes and the window frames. This type of glazing compound is generally considered to be a non-friable organically bound material and was observed to be in fair/poor condition.

View of the asbestos-containing interior window glazing
compound located in the Grinder & Turbine Rooms.

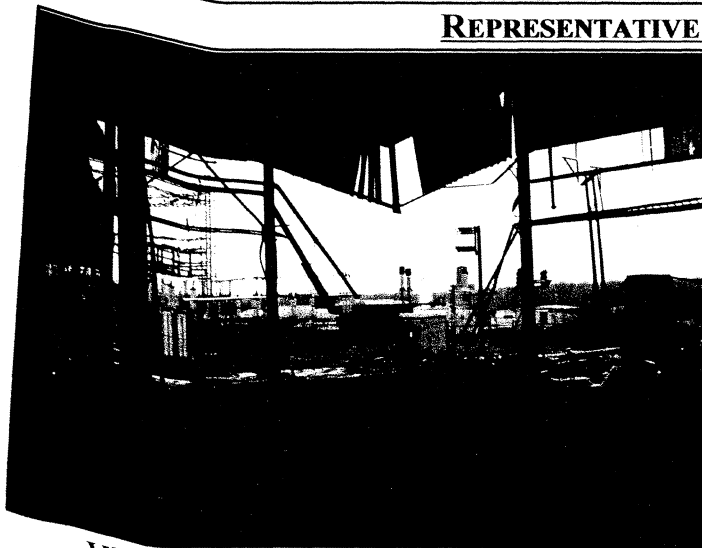
View of the northwest portion of Area 1-10 of the
Debarking/Wood Room with building material debris/damage.

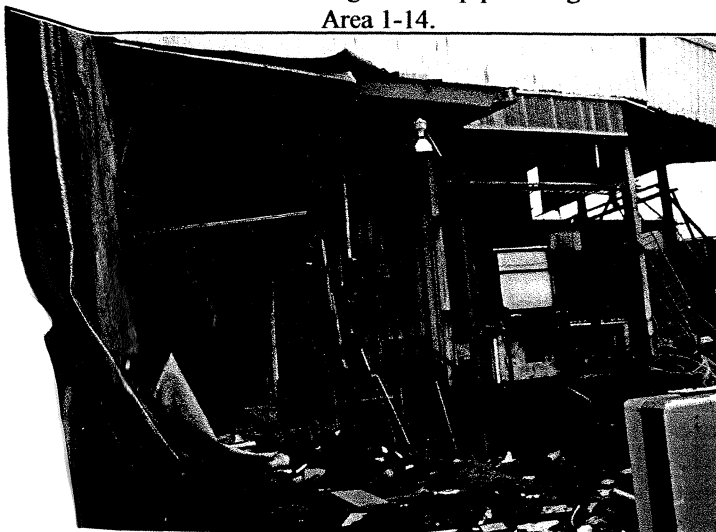
ew of the debris/damage of Areas 1-39 of the Dewatering
Building & Area 1-10 of the Debarking/Wood Rooms.

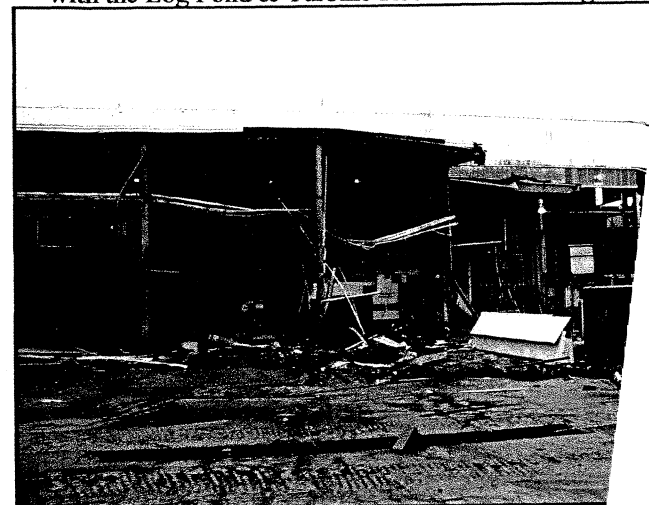
View of the debris/damage of the west end of the north
the Dewatering Building.

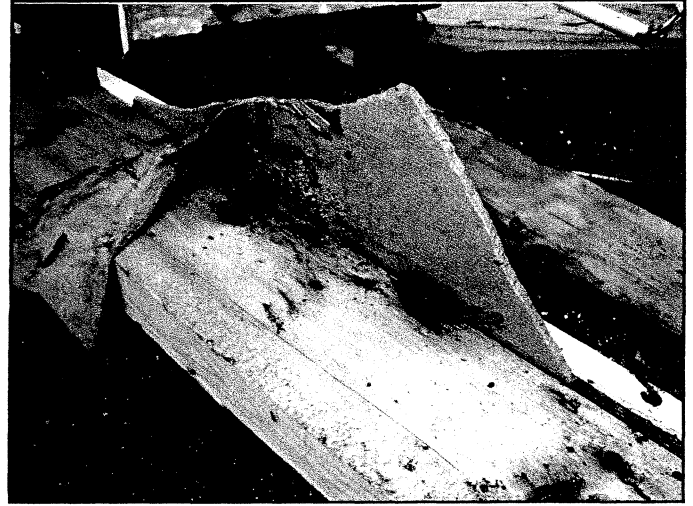
View of the transite siding debris located in Area 1-39 of the
Dewatering Building.

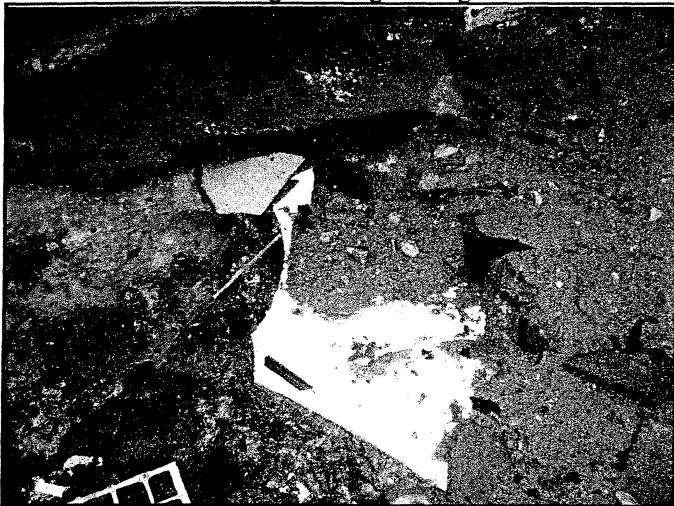
View of asbestos-containing transite and roofing debris located
in Area 1-39 of the Dewatering Building.

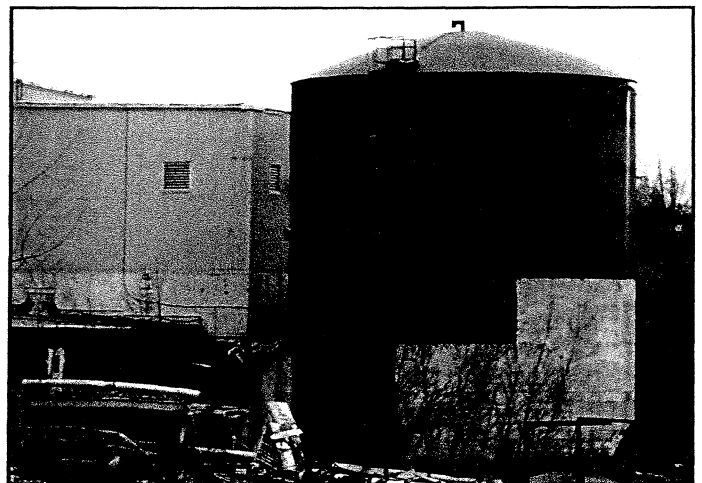
Approximately four-thousand square feet (4,000 ft²) of asbestos-containing gray/black coating material was identified on the roof and the exterior sides of the large holding tank located to the west of the Bleach Plant. The coating is considered to be a non-friable organically bound material and was observed to be in poor condition with areas of damage and coating missing. This missing coating may or may not be located along the grounds around the tank. It appears that the coating is located on metal panels which are along the exterior of the tank.

View of the large holding tank with asbestos-containing
gray/black coating on the walls and roof.

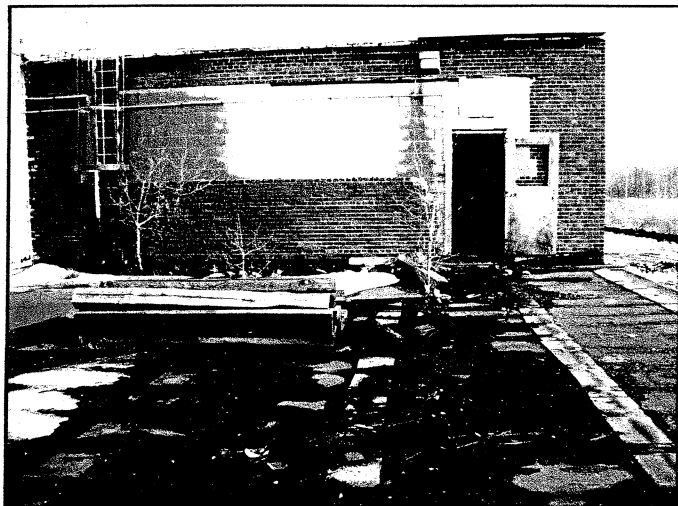
Approximately one-thousand seven-hundred fifty square feet (1,750 ft²) of asbestos-containing built-up roofing layers over black paper was identified on Roof Area R-1. The built-up roofing and the black paper are generally considered to be non-friable organically bound materials and were observed to be in poor condition.

View of Roof Area R-1 with asbestos-containing built-up roofing over black paper.

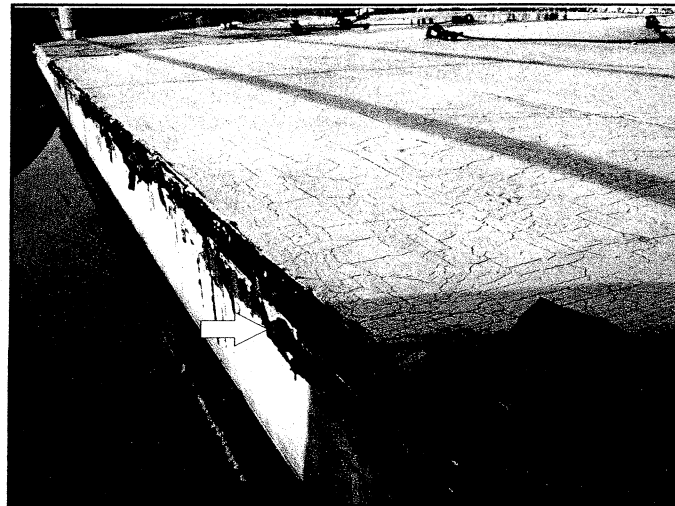
Approximately one-hundred ten linear feet (110 lf) of asbestos-containing black flashing material was identified around the side of the large hatch door located on Roof Area R-4. This type of flashing is generally considered to be a non-friable organically bound material and was observed to be in fair condition.

View of asbestos-containing flashing material associated with large hatch doors on Roof Area R-4.

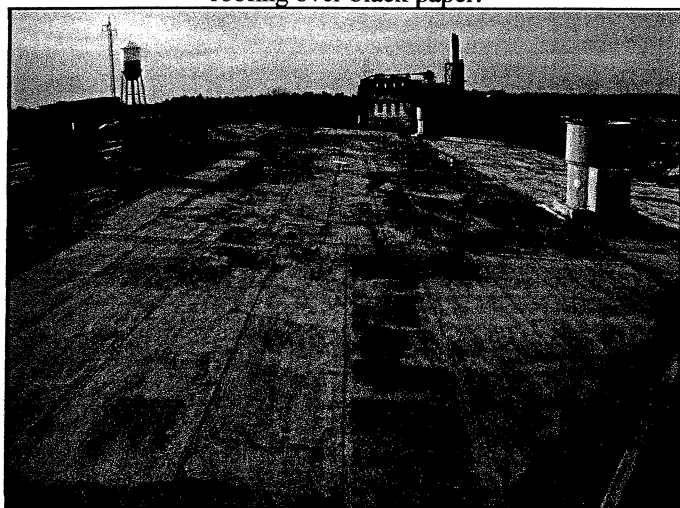
Approximately twenty eight-thousand five-hundred twenty square feet (28,520 ft²) of asbestos-containing aluminum coated built-up roofing/built-up roofing layers over brown paper including all of the flashing materials was identified on Roof Area R-5. The flashing materials are located along vents, pipes, support structures, walls, etc. The roofing layers and flashing materials are generally considered to be a non-friable organically bound materials and were observed to be in fair condition.

View of Roof Area R-5 with various asbestos-containing roofing layers and flashing materials.

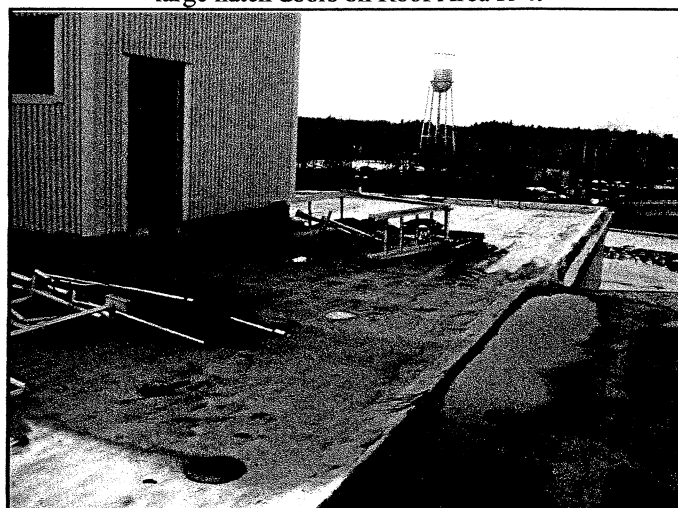
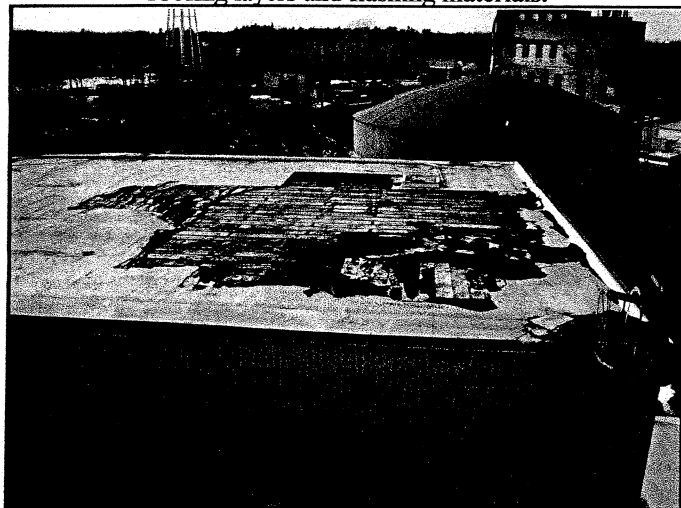
Approximately six-thousand one-hundred seventy square feet (6,170 ft²) of asbestos-containing aluminum coated built-up roofing over black paper including all of the flashing materials was identified on Roof Areas R-6 and R-7. The flashing materials are located along vents, pipes, support structures, walls, etc. The roofing layers and flashing materials are generally considered to be a non-friable organically bound materials and were observed to be in fair condition.

View of Roof Area R-6 with asbestos-containing built-up roofing over black paper and flashing materials.

View of Roof Area R-7 with asbestos-containing built-up roofing over black paper and flashing materials.

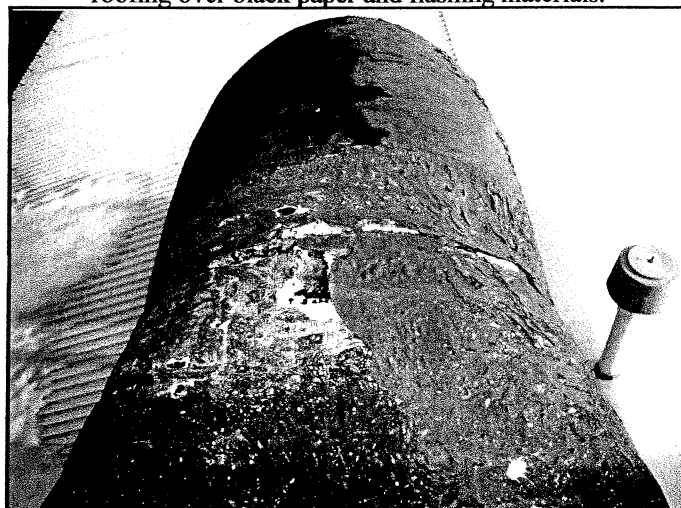
fiberglass insulation was identified on the large vent pipe located on the west end of Roof Area R-8. This type of coating/paper is generally considered to be a non-friable organically bound material and was observed to be in fair condition.

View of asbestos-containing black coating/paper on fiberglass insulation to large vent pipe located on Roof Area R-8.

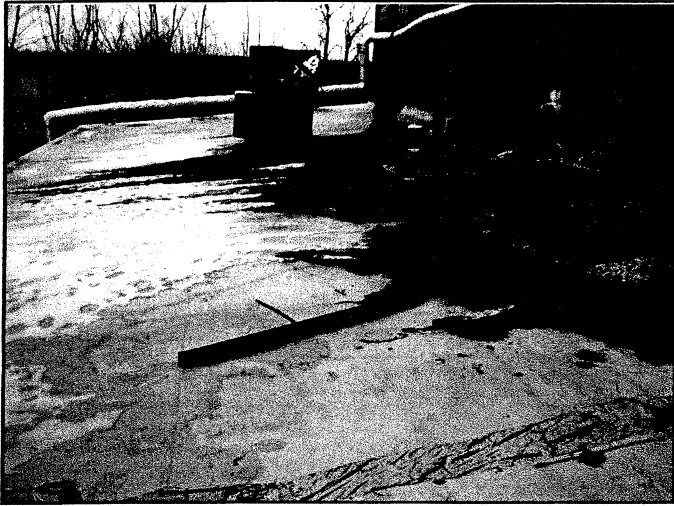
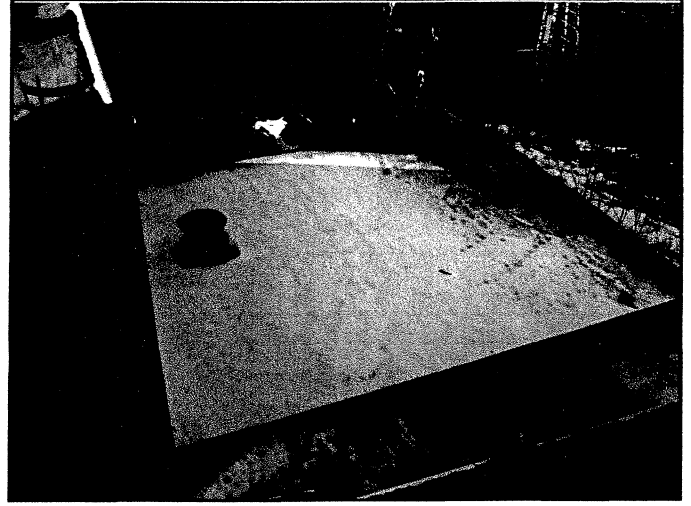
Approximately twenty-thousand two-hundred twenty four square feet (20,224 ft²) of asbestos-containing aluminum coated built-up roofing including all of the flashing materials was identified on Roof Areas R-9, R-10 and R-11. The flashing materials are located along vents, pipes, support structures, walls, etc. The roofing and flashing materials are generally considered to be non-friable organically bound materials and were observed to be in fair condition on Roof Areas R-9 and R-10 and in poor condition on Roof Area R-11 with a portion of the roof being bent/damaged.

View of Roof Area R-9 with asbestos-containing built-up roofing layers and flashing materials.

View of Roof Area R-10 with asbestos-containing built-up roofing layers and flashing materials.

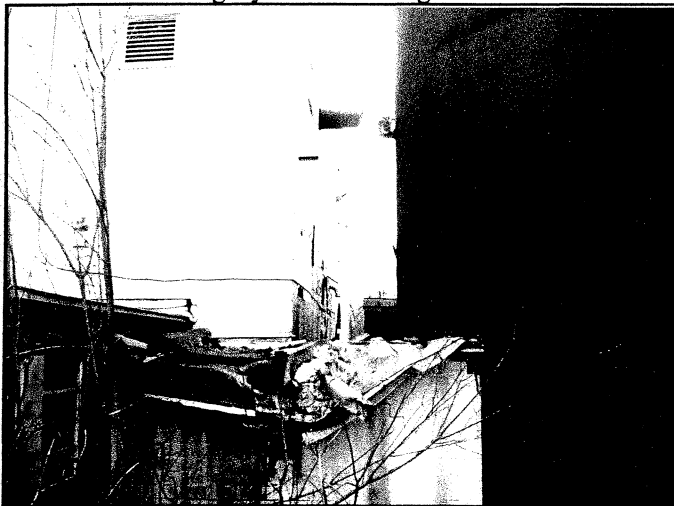
Approximately one-hundred square feet (100 ft²) of roofing materials was assumed to be asbestos-containing on the small roof located between Roof Area R-10 and the large holding tank. The roof was deteriorating and was considered to be too unsafe to sample. The roofing materials are generally considered to be a non-friable organically bound materials and were observed to be in poor condition.

View of the roof between Roof Area R-10 and the large holding with assumed asbestos-containing materials.

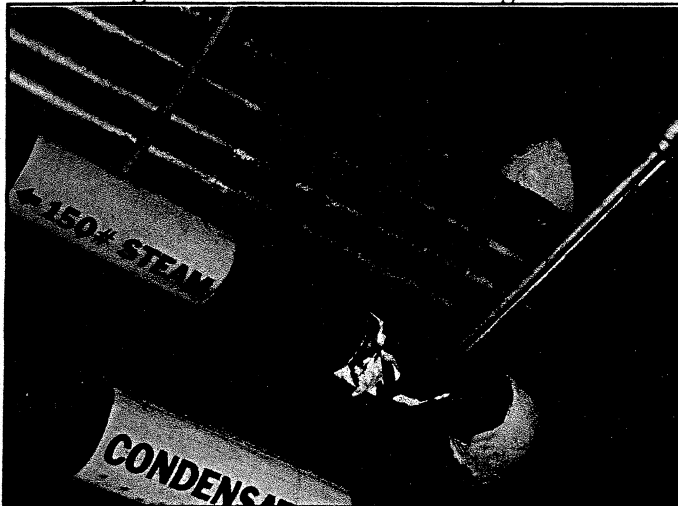
Approximately five-hundred seventy five linear feet (575 lf) of asbestos-containing black paper over white pipe insulation and associated mudded fittings were identified in Areas 1-37, 1-34, 1-35, 1-10, 2-1 and 1-14. The white portion of this insulation is generally considered to be a friable material while the black paper jacket is generally considered to be a non-friable organically bound material. The pipe insulation was found to be relatively poor condition in Areas 1-37, 1-10, 2-1 and 1-14 and was found to be in very poor condition with debris noted in Areas 1-34 and 1-35 which was mixed in with building material debris. There is approximately seven-thousand square feet (7,000 ft²) of floor space in Areas 1-34 and 1-35.

View of the asbestos-containing pipe insulation and fittings located in Area 1-37 of the Screen Room.

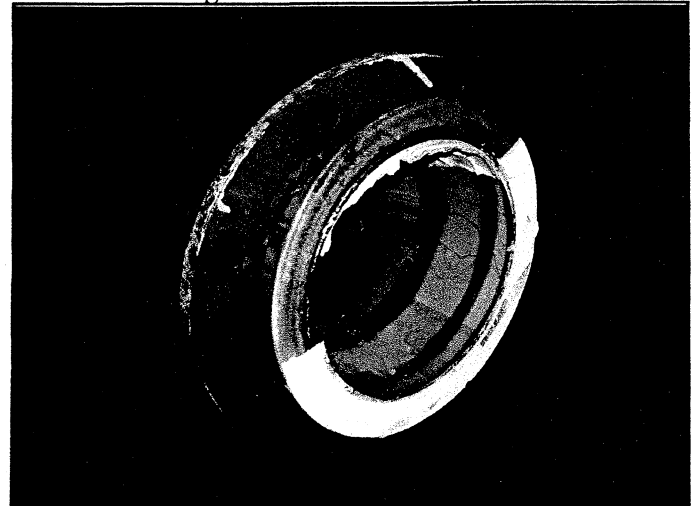
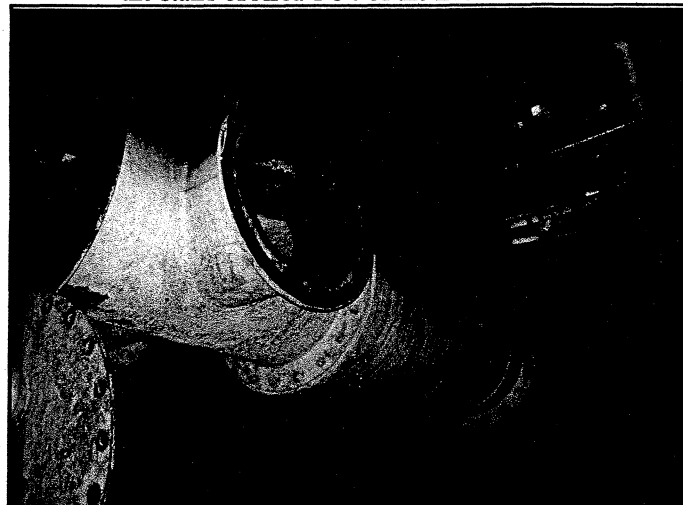
There were asbestos-containing gaskets to flanges and valves identified in Areas 1-37, 1-38, 1-34 and 1-35. The gaskets are located on either disassembled or intact flanges and valves pipes. These types of gaskets are generally considered to be non-friable materials. Although one of the gaskets sampled was found to be non-asbestos, all gaskets should be considered to be asbestos-containing unless otherwise tested. The gaskets located in Areas 1-37 and 1-38 were found to be in fair condition. The gaskets located in Areas 1-34 and 1-35 were found to be either intact or broken and mixed in with building material debris. There is approximately seven-thousand square feet (7,000 ft²) of floor space in Areas 1-34 and 1-35.

View of a typical asbestos-containing gasket located in Areas 1-37 and 1-38 of the Cleaner and Screen Rooms.

View of a typical asbestos-containing gasket located in Areas 1-34 and 1-35 of the Bleach Plant.

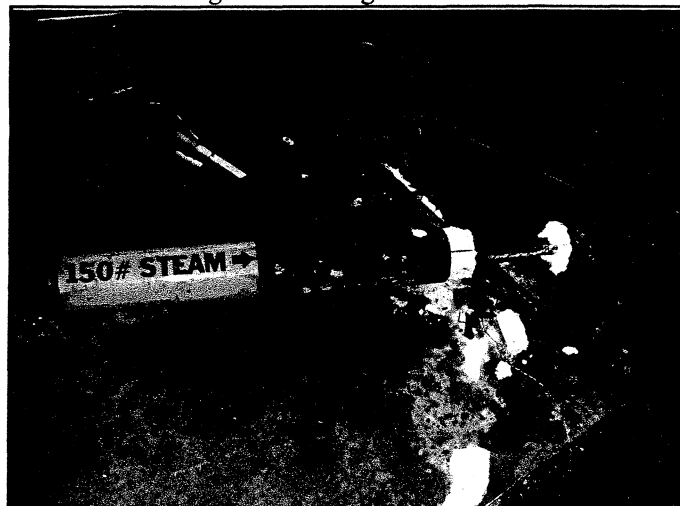
View of asbestos-containing pipe insulation debris located on the stairs of Area 1-34 of the Bleach Plant.

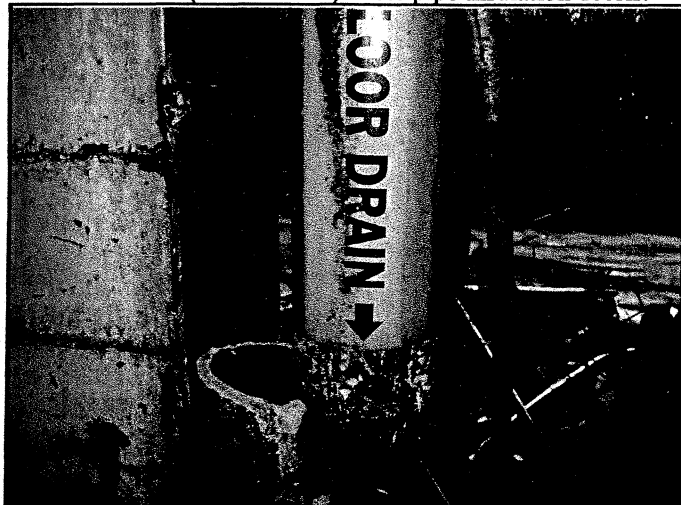
A total of approximately one-hundred twenty linear feet (120 lf) of asbestos-containing transite pipes were identified in Areas 1-37, 1-34 and 1-35. The pipes were labeled as drain pipes. This type of transite pipe is generally considered to be a non-friable material. The pipe located in Area 1-37 is in fair condition along the southeast corner. The pipes located in Areas 1-34 and 1-35 were found to be either intact or broken and mixed in with building material debris. There is a large pipe leaning on the wall at the southeast corner of Area 1-35. There is approximately seven-thousand square feet (7,000 ft²) of floor space in Areas 1-34 and 1-35.

View of one of the asbestos-containing transite pipes located in Areas 1-34 & 1-35 of the Bleach Plant.
